Regarding: Project: 09-73109-11; Pahrump Community Center  
EML ID: 738341

**SPORE TRAP REPORT: NON-VIABLE METHODOLOGY**

**Attachment C**  
**Photographs**

### *Limited Asbestos Consulting Services Report*

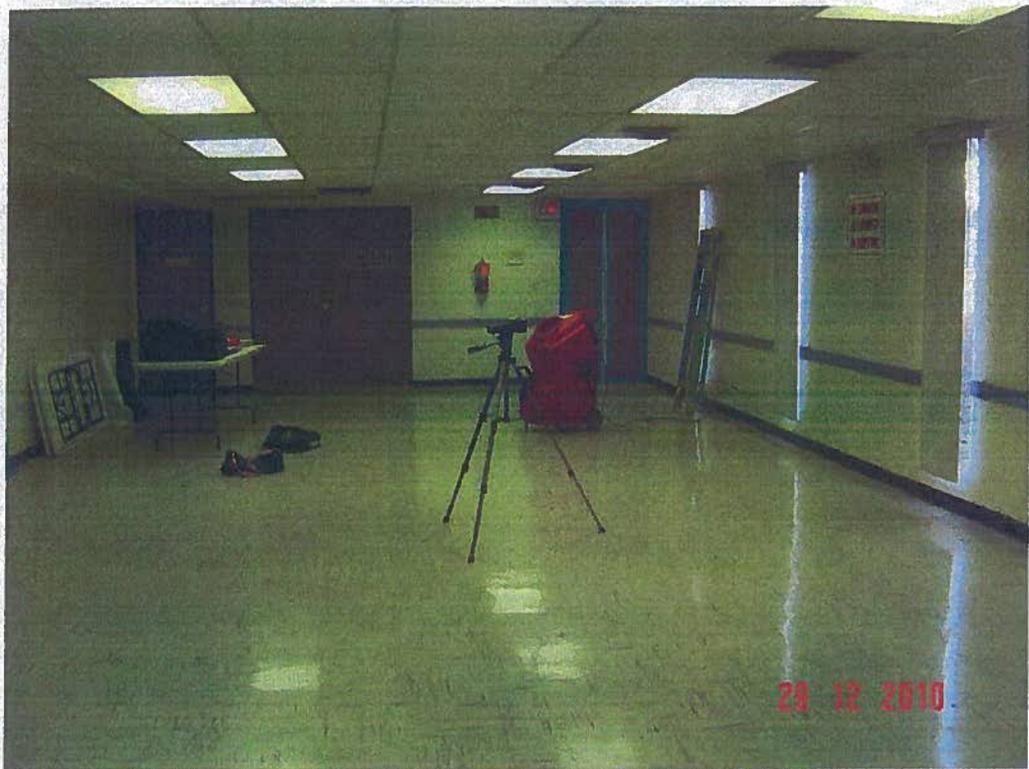
**Photo #1:  
Sample  
PCC-IA-01  
was collected  
from the  
middle of  
room B.**

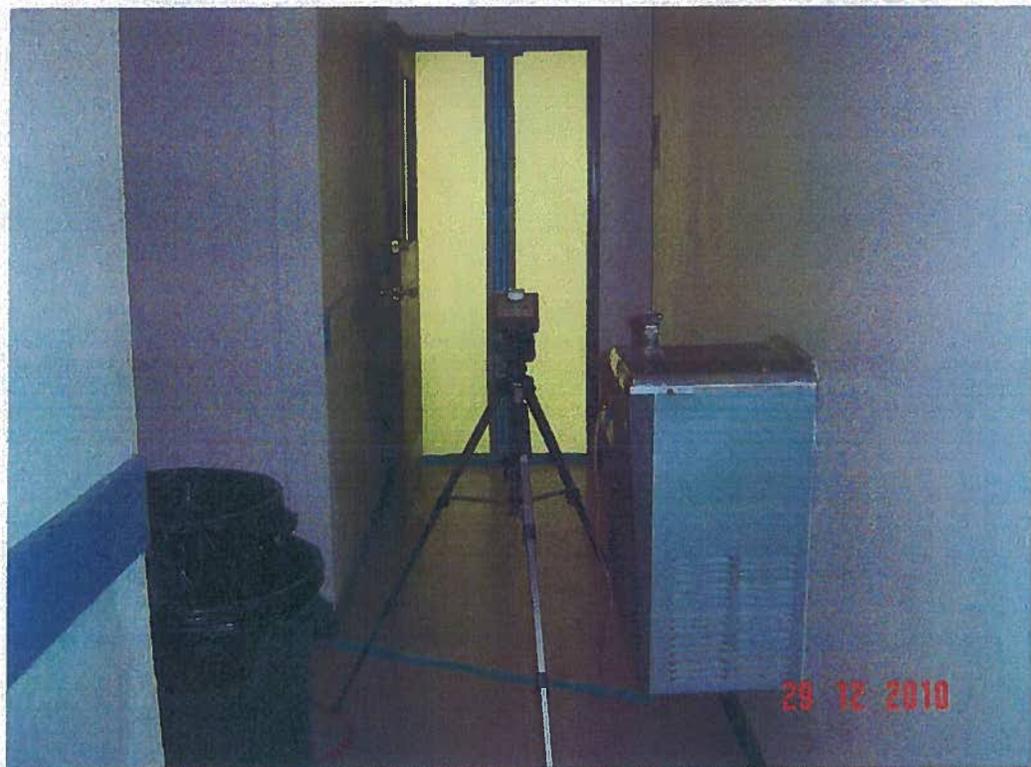
**Photo #2:  
Sample  
PCC-IA-02  
was collected  
from the  
restroom hall  
between  
rooms A&B.**

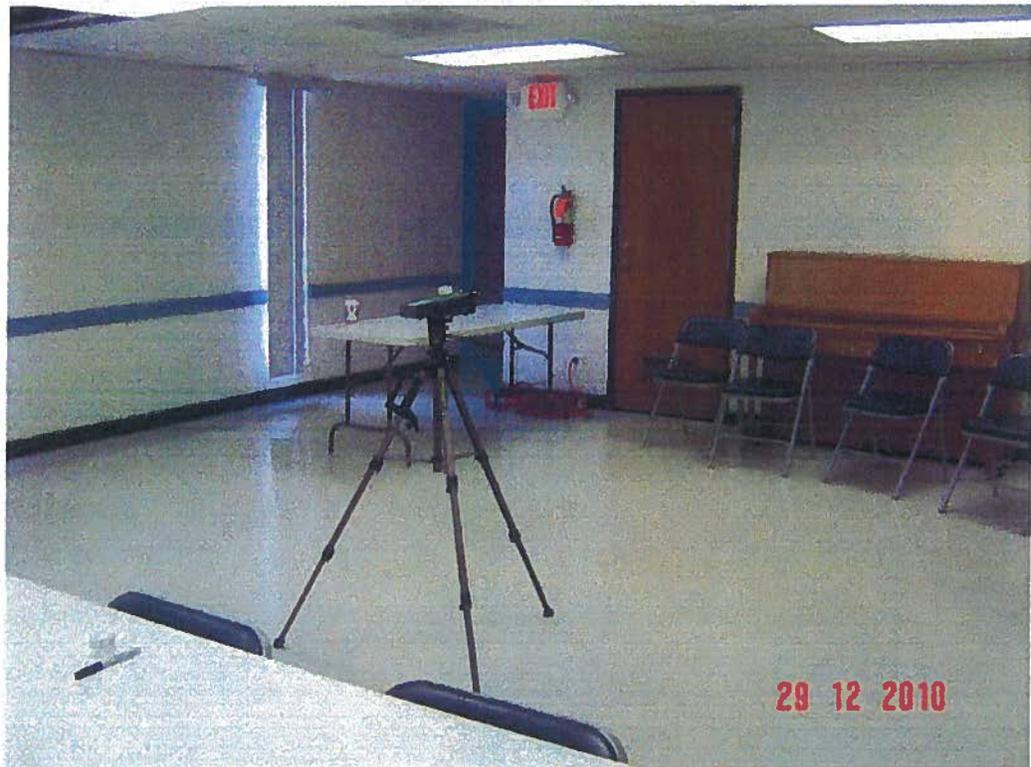
**Photo #3:  
Sample  
PCC-IA-03  
was collected  
from the  
middle of  
room A.**

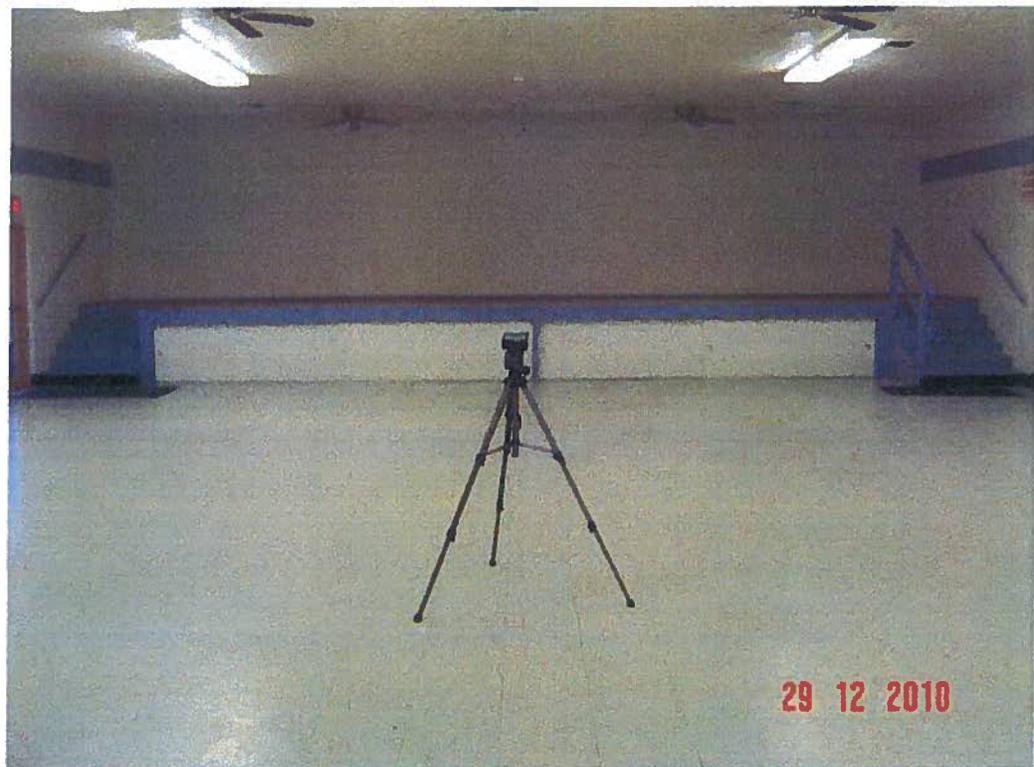
**Photo #4:  
Sample  
PCC-IA-04  
was collected  
from the  
main room  
in front of  
the stage.**

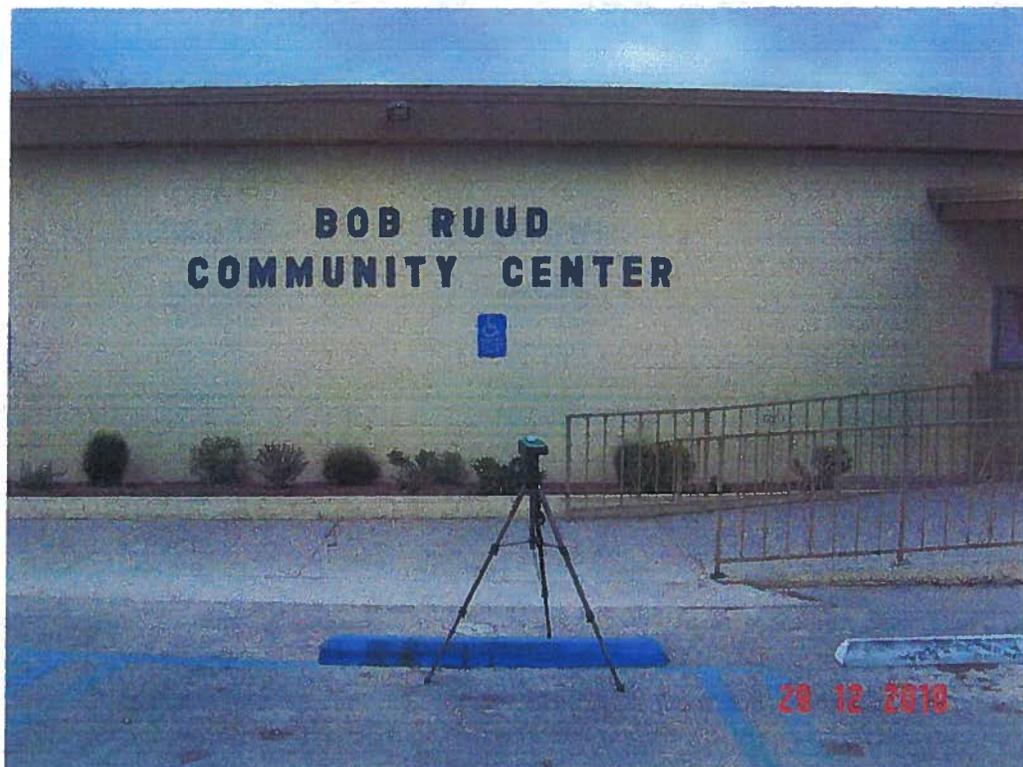
**Photo #5:**  
Sample  
PCC-OA-05  
was collected  
outdoors in  
front of the  
building.

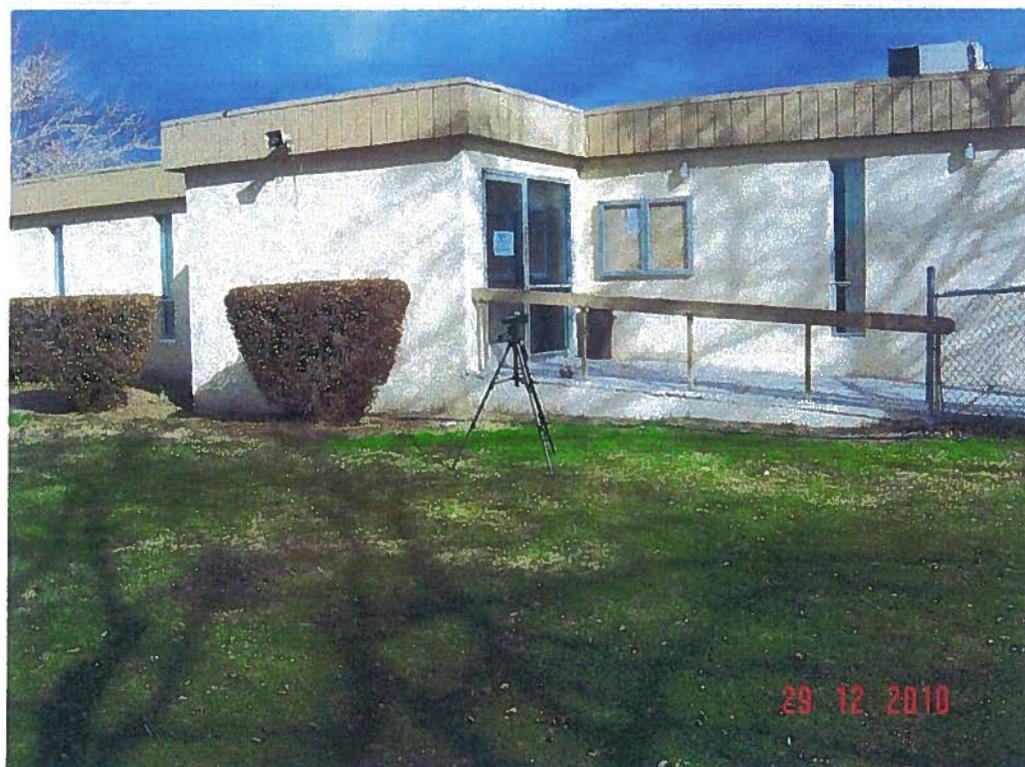
**Photo #6:**  
Sample  
PCC-OA-06  
was collected  
outdoors in  
back of the  
building

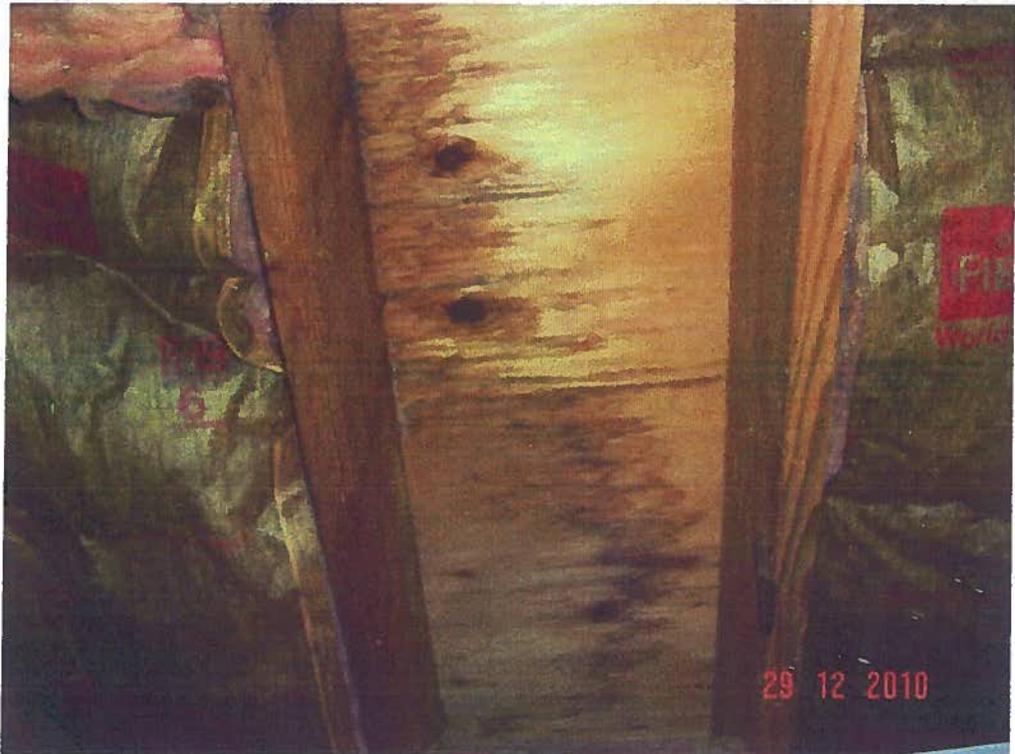
**Photo #8:  
Room B  
water  
damaged  
and stained  
area above  
the drop  
ceiling.**

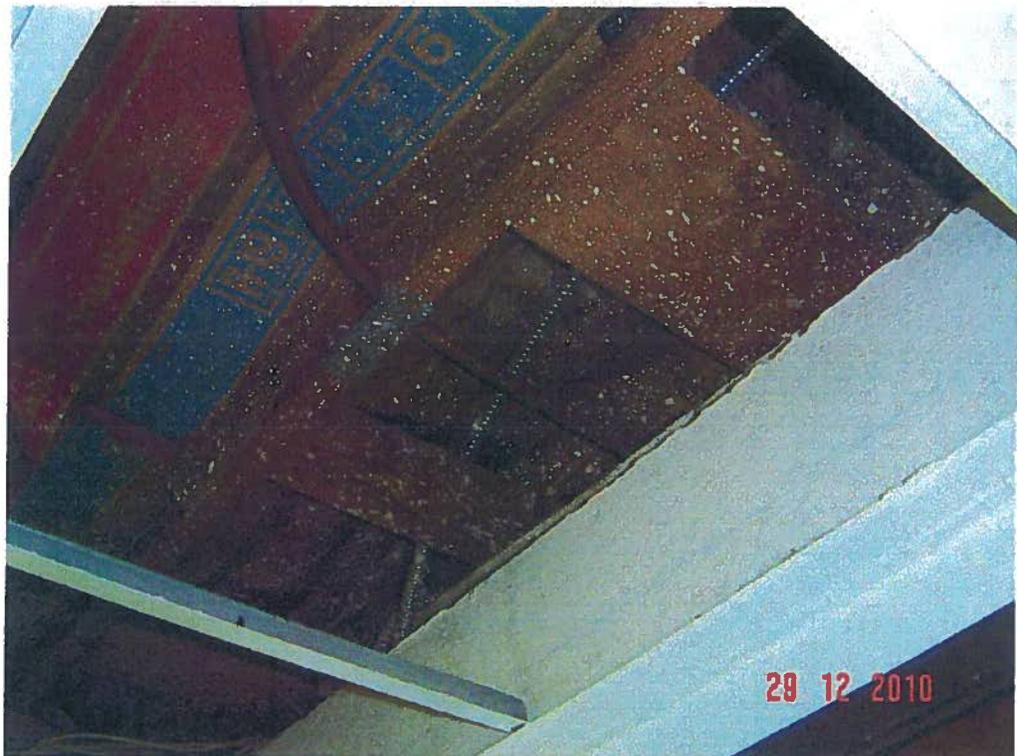
**Photo #9:  
Room B  
water  
damaged  
and stained  
area above  
the drop  
ceiling.**

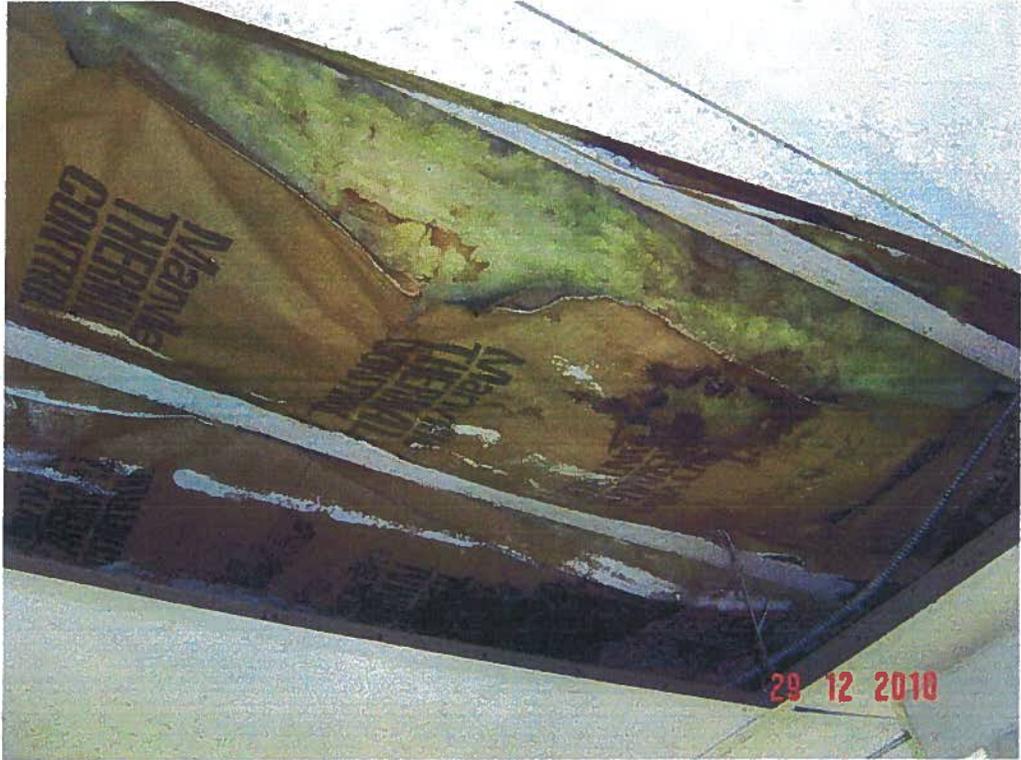
**Photo #10:  
Room A  
water  
damaged  
and stained  
area above  
the drop  
ceiling.**

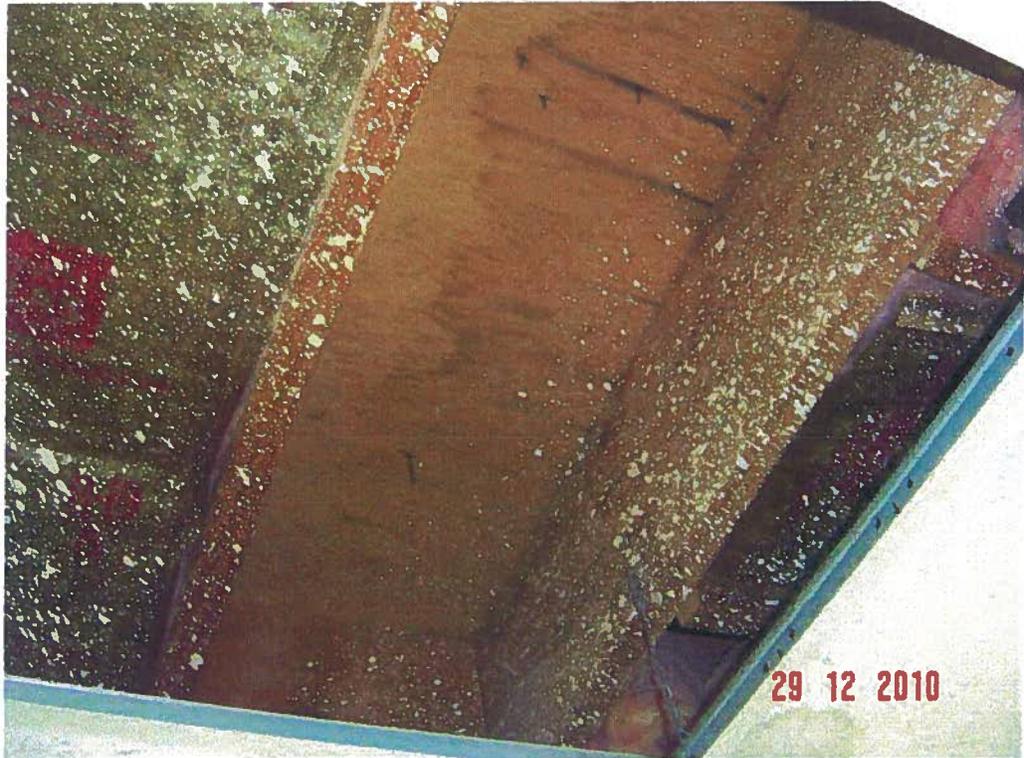
**Photo #11:  
Room A  
water  
damaged  
and stained  
area above  
the drop  
ceiling**

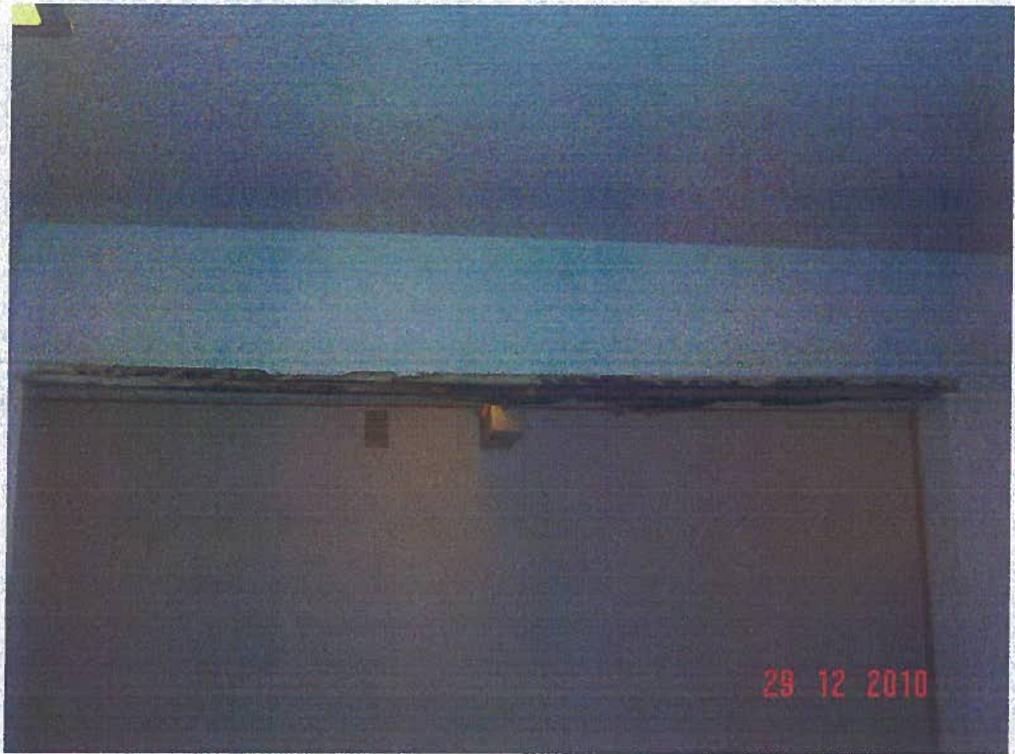
**Photo #12:  
Mold and  
water  
damaged  
Arch located  
in the  
restroom  
hall.**

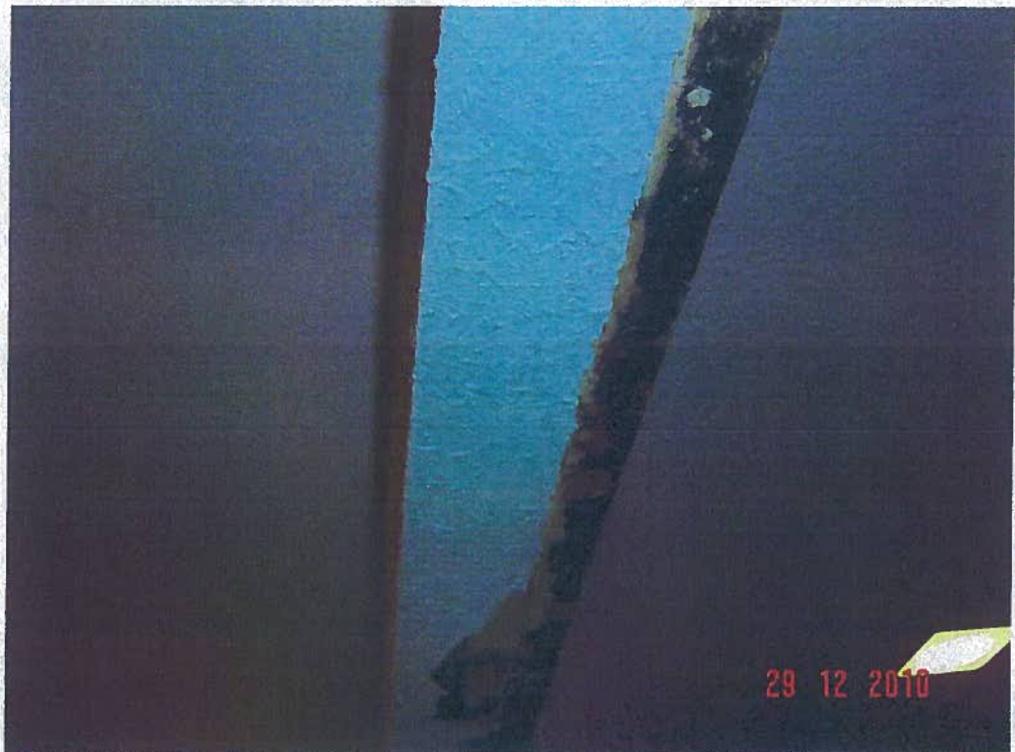
**Photo #13:  
Mold and  
water  
damaged  
Arch located  
in the  
restroom  
hall.**

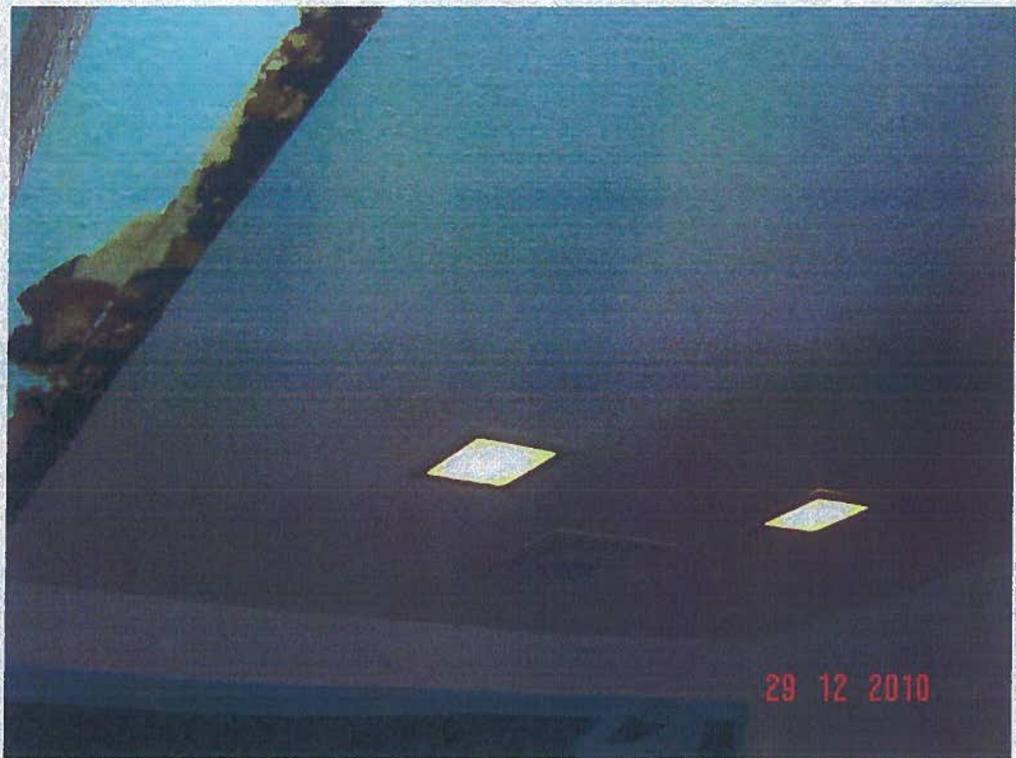
**Photo #14:**  
water  
damaged  
ceiling  
located in  
the area next  
to the arch.

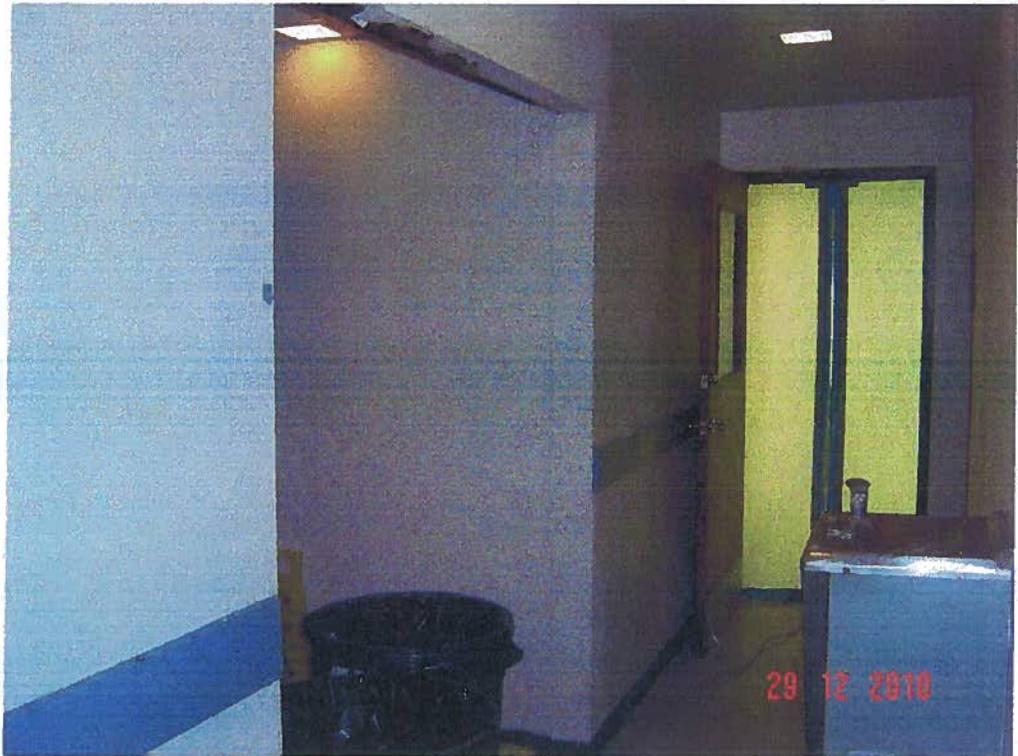
**Photo #16:**  
water  
damaged  
walls located  
in the  
restroom hall  
next to the  
arch.

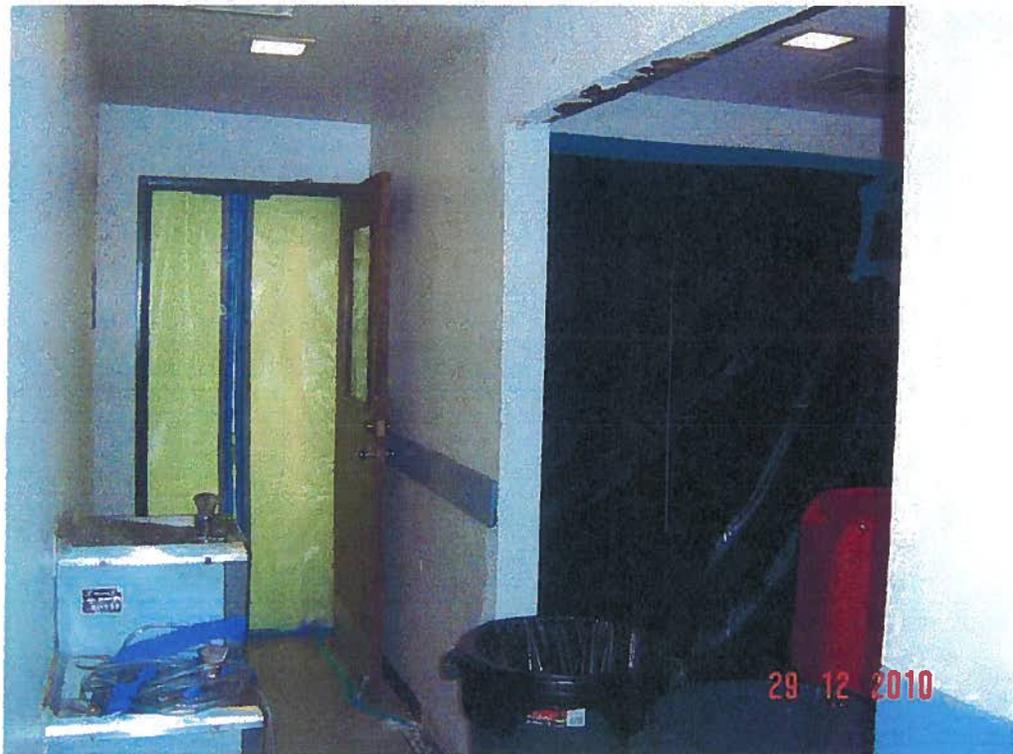
**Photo #17:**  
water  
damaged  
walls located  
in the  
restroom hall  
next to the  
arch
