## **6 SITE RECONNAISSANCE**

### **6.3. SITE OBSERVATIONS**

#### 6.4. RESULTS OF SITE RECONNAISSANCE

Bob Ruud Community Center  
 150 North Highway 160  
 Pahrump, Nye County, Nevada

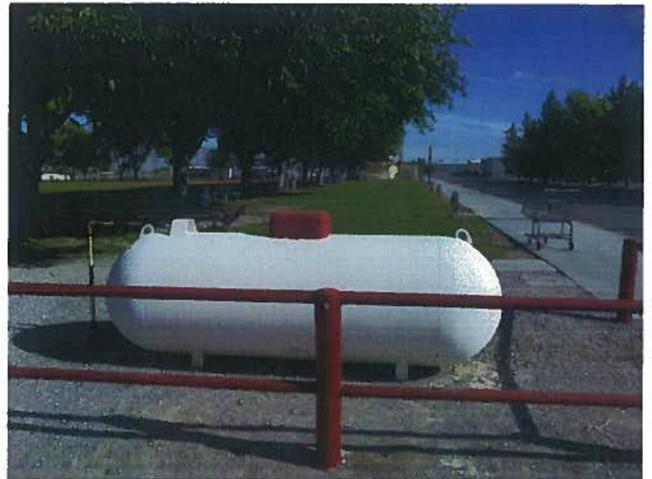
On the exterior, an AST containing propane was observed. Surface staining was on the access road to the park grounds, located between the Subject property and the propane AST. This staining appears to be in the area where one of the two septic tanks was reported to be located.

Above ground Propane tank

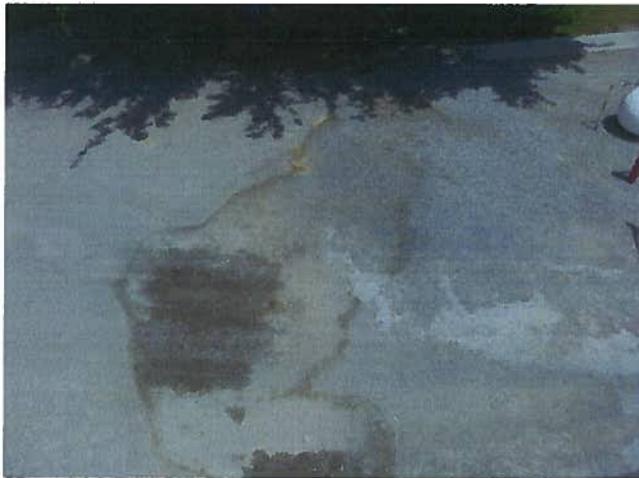
- Surface stained soil was observed in the area where one of the two septic/leach fields areas is reportedly located.

Stained surface – in area of reported septic tank  
(near propane tank)

- Poor best management practices were observed in the supply storage closet. Spilled floor seal/resin type material was observed. Kleinfelder recommends that spills be cleaned and leaking containers be appropriately disposed.
- Surface stained soil was observed in the area where one of the two septic/leach fields areas is reportedly located. The Town of Pahrump should verify whether the surface staining is located above the septic/leach field and if so evaluate if the septic/leach field is functional.

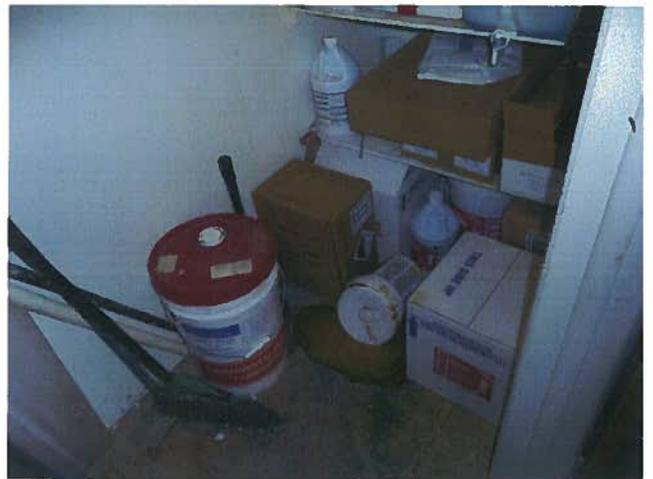
At the time of our site reconnaissance, we observed 5-gallon size containers of corrosive liquids, floor stripping, cleaning and sealant products and some smaller containers of cleaning supplies, within a supply closet. One of the containers, containing an unidentified resin type material, had leaked.

- Poor best management practices were observed in the supply storage closet. Spilled floor seal/resin type material was observed.

Storage/supply closet

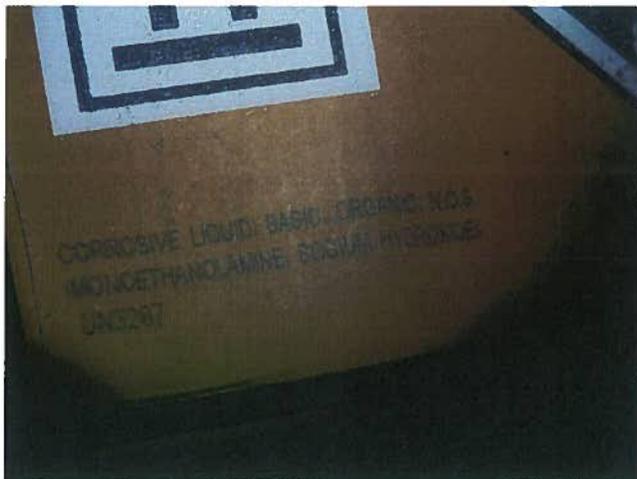
Corrosive liquid in storage /supply closet

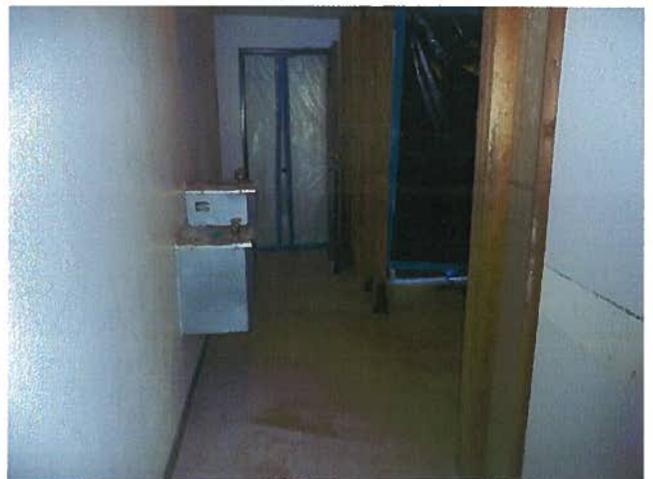
Mr. Luis was subsequently asked about chemicals stored on site and a previous environmental cleanup noted in a User Questionnaire provided by the Client (Section 7.2). Mr. Luis indicated that only standard, over-the-counter cleaning supplies and paints were stored on the subject property. To his knowledge, no hazardous materials have been used or stored on the subject property. He also indicated that the previous environmental cleanup consisted of abatement of mold caused by water intrusion in the building.

Portion of building with containment (mold remediation) *Original in Color*

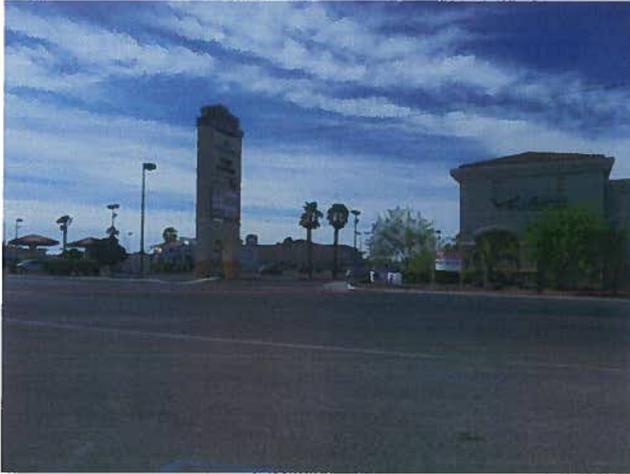
The site perimeter was walked and adjacent properties observed (as viewable from the subject property and public rights of way). A Rebel Oil fuel station, with USTs, is located on the south adjacent property (separated from the subject property by East Basin Avenue).

Adjacent property – shopping center with Rebel Oil Fuel Station

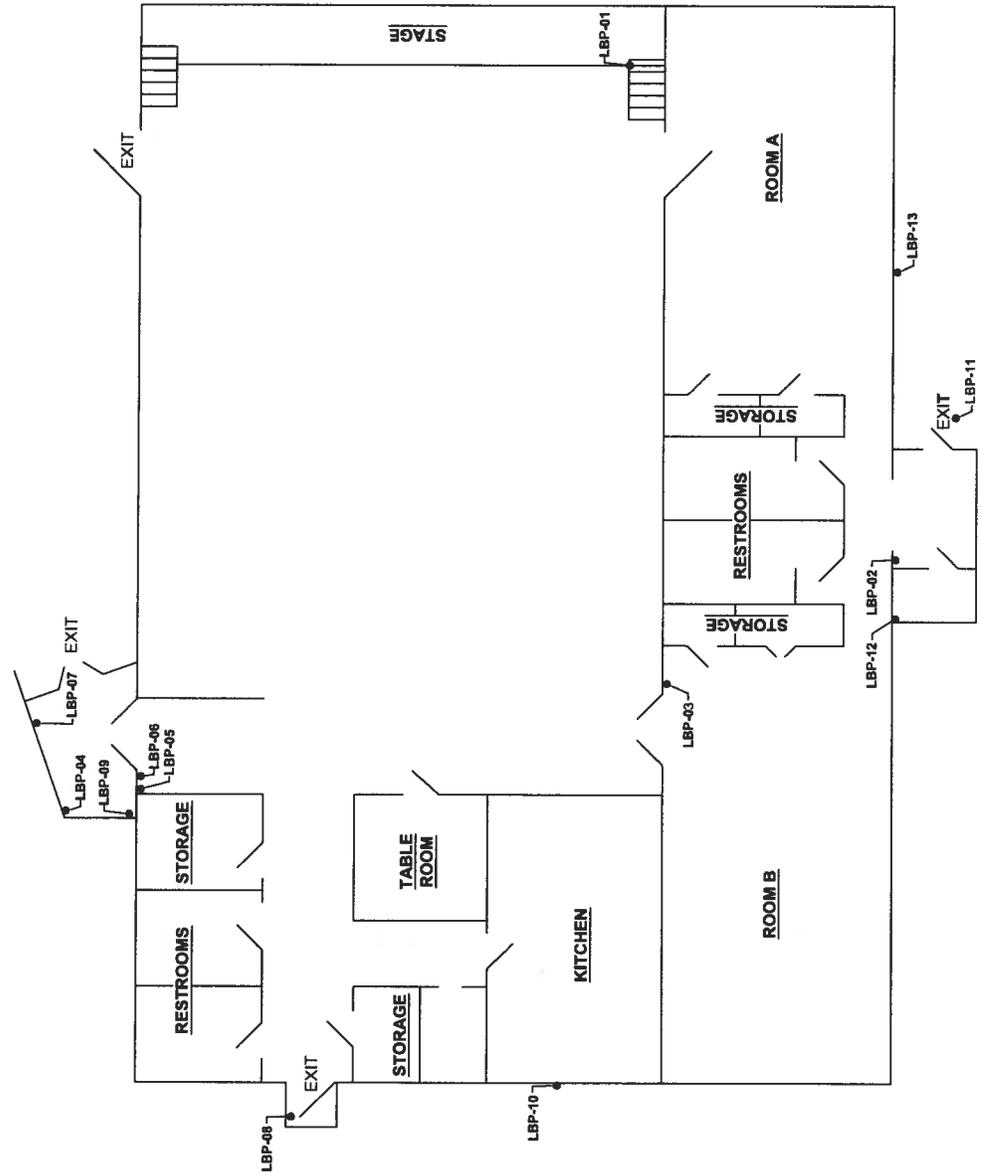
A summary of Kleinfelder's lead based paint survey analytical results is provided in Table 6-4. The lead based paint sample location map is provided as Plate 7. Copies of the lead paint analytical laboratory report and chain-of-custody forms are provided in Appendix H.

Sample Number	Description/Location
LBP-01	Blue; Interior Stage Handrail
LBP-02	White; Interior Wallboard
LBP-03	White; Interior 16" x 8" CMU Wall
LBP-04	White; Interior 16" x 3 1/2" Brick Wall
LBP-05	Tan; Exterior Roof Flashing
LBP-06	Brown; Exterior Roof Flashing/Titan
LBP-07	Tan; Exterior Block Wall
LBP-08	Blue; Exterior Stoop/Stairs
LBP-09	Tan; Interior Window Caulk
LBP-10	White; Exterior Window Caulk
LBP-11	Brown; Exterior Wood Railing
LBP-12	Brown/Green; Roof Cap Flashing
LBP-13	Gray; Exterior Window Caulk
